Home Inspection Report

468 Rodriguez Avenue, Martinez

Jose Gonzales Vargas
May 27, 2022

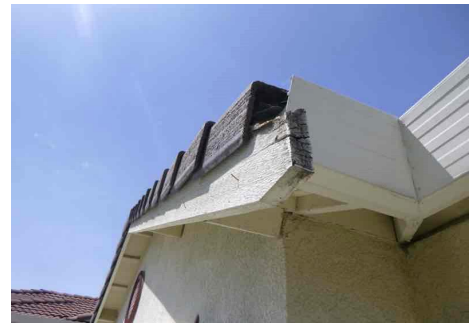
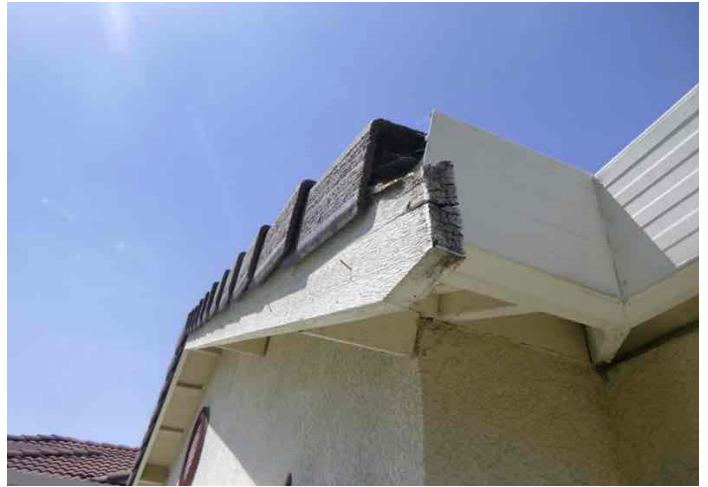
Photo 02

1. Water damage was observed to the rafters at various locations. We recommend the services of a licensed general contractor and/or structural pest control company. (See Photo 2)

- ! 1. Water damage was observed to the rafters at various locations. We recommend the services of a licensed general contractor and/or structural pest control company. (See Photo 2)

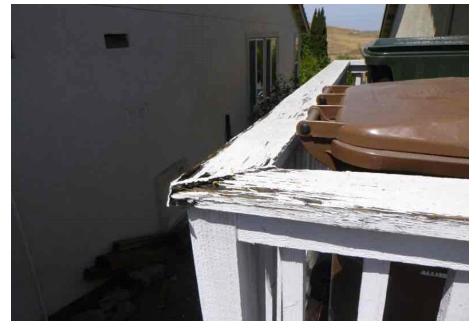
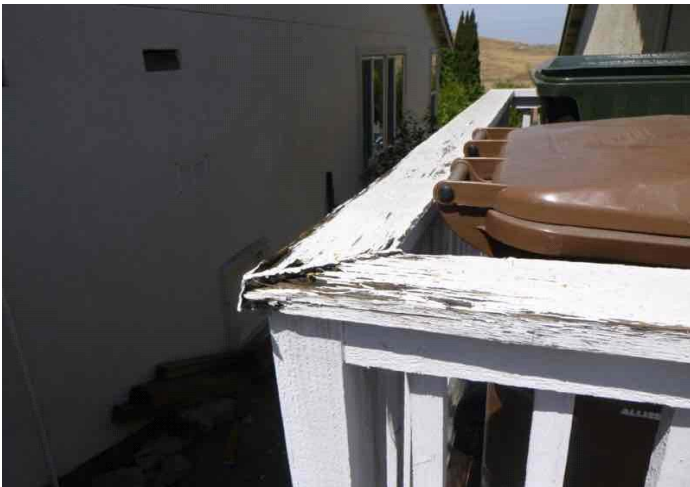
Photo 03

2. The railing at various locations are water damaged. We recommend the services of a licensed general contractor and/or structural pest control company. (See Photo 3)

- ! 2. The railing at various locations are water damaged. We recommend the services of a licensed general contractor and/or structural pest control company. (See Photo 3)

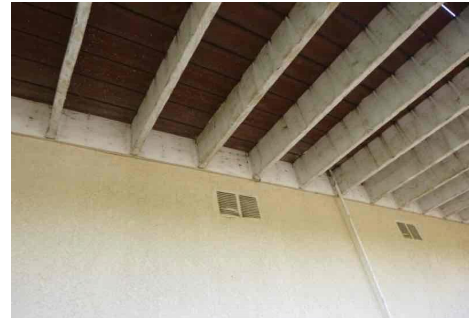
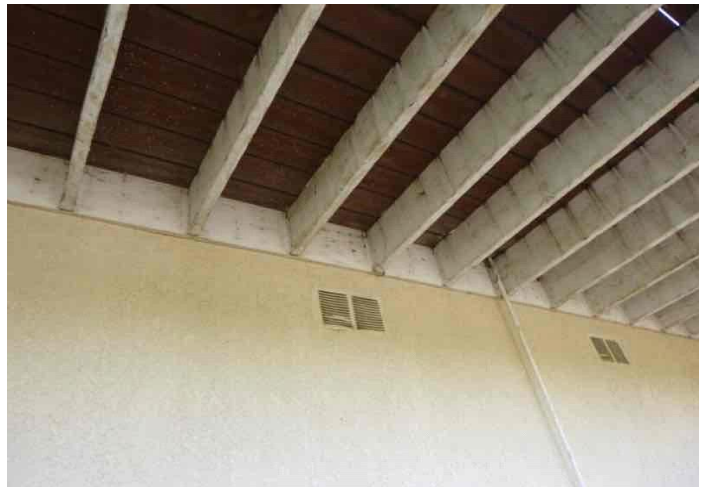
Photo 04

3. The deck at the rear appears to be attached to the structure with nails/screws through the end ledger boards. Decks should be attached to the structure with flashing and properly sized and spaced lag bolts. We recommend the services of a licensed general contractor. (See Photo 4)

- ! 3. The deck at the rear appears to be attached to the structure with nails/screws through the end ledger boards. Decks should be attached to the structure with flashing and properly sized and spaced lag bolts. We recommend the services of a licensed general contractor. (See Photo 4)

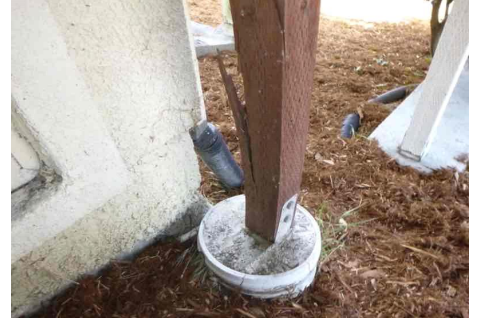
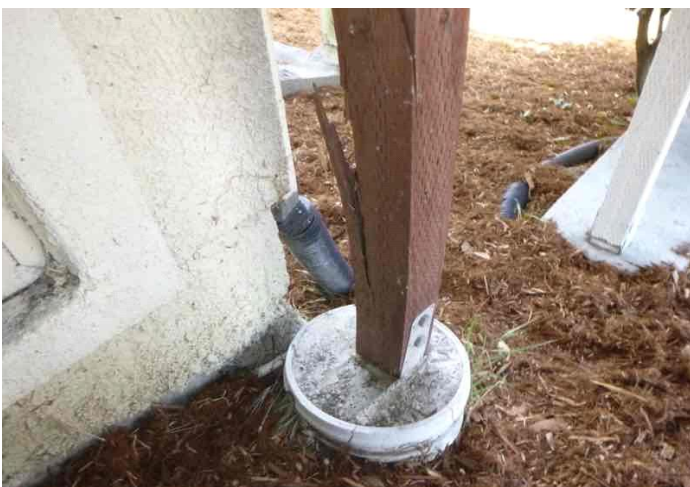
Photo 05

4. The deck has a concrete pier being used as the foundation support for the deck framing. These pier blocks typically require poured concrete footings to provide adequate support for the load posts and deck framing. We recommend the services of a licensed general contractor. (See Photo 5)

- ! 4. The deck has a concrete pier being used as the foundation support for the deck framing. These pier blocks typically require poured concrete footings to provide adequate support for the load posts and deck framing. We recommend the services of a licensed general contractor. (See Photo 5)

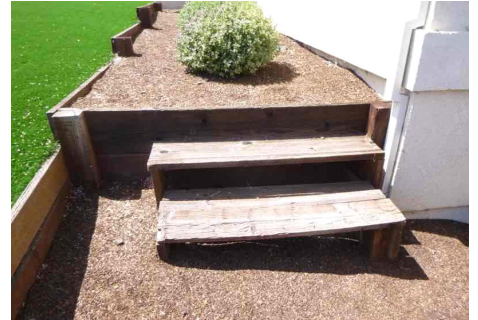
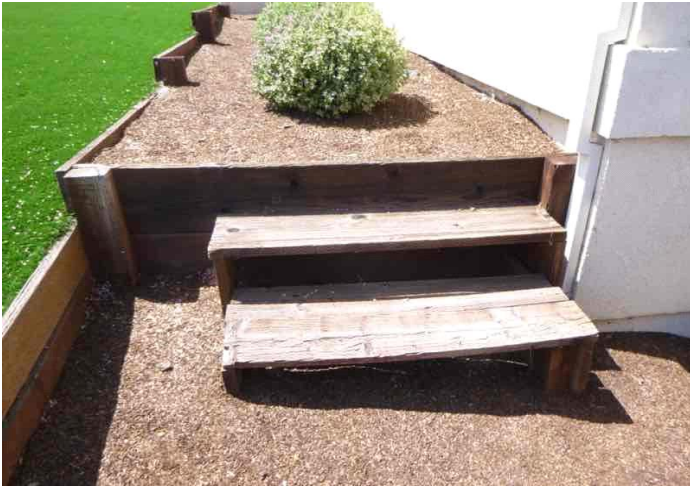
Photo 01

5. The steps at the front appear to be non-conforming. This could create a potential fall hazard. We recommend the services of a licensed general contractor. (See Illustration 3R) (See Photo 1)

- ! 5. The steps at the front appear to be non-conforming. This could create a potential fall hazard. We recommend the services of a licensed general contractor. (See Illustration 3R) (See Photo 1)

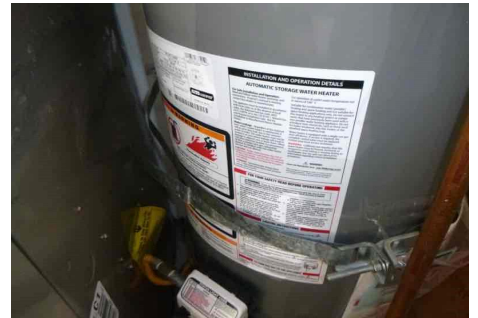
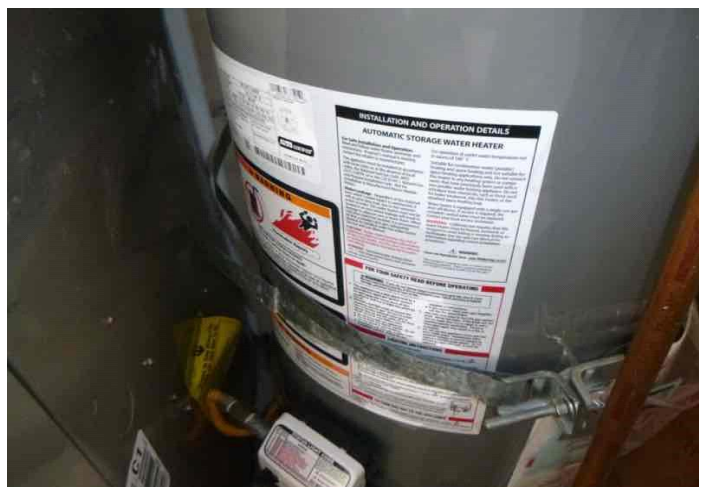
Photo 06

6. The water heater seismic straps are loose, this will allow movement of the tank in an earthquake. We recommend tightening the straps and/or adding bracing between the tank and wall to improve safety. (See Photo 6)

- ! 1. The water heater seismic straps are loose, this will allow movement of the tank in an earthquake. We recommend tightening the straps and/or adding bracing between the tank and wall to improve safety. (See Photo 6)

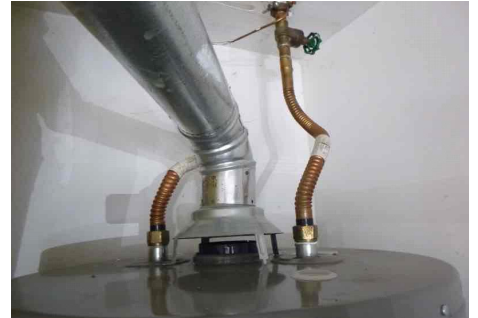
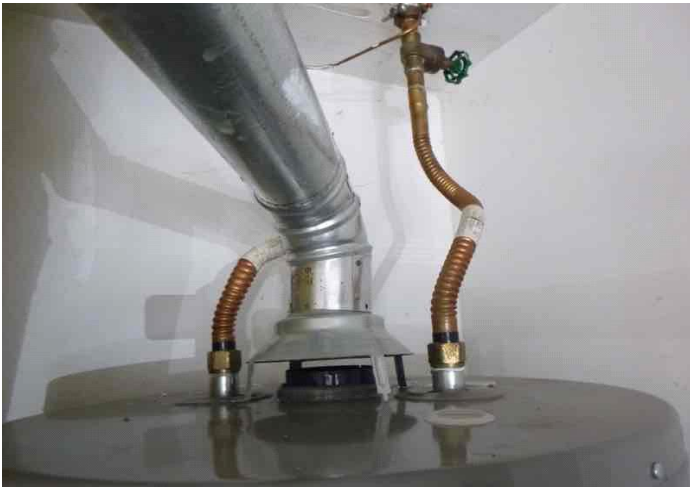
Photo 07

7. For enhanced safety, it is recommended that the loose or damaged connections of the water heater venting system be improved. A minimum of 3 screws at each section of the duct is recommended. (See Illustration 8M) (See Photo 7)

- ! 2. For enhanced safety, it is recommended that the loose or damaged connections of the water heater venting system be improved. A minimum of 3 screws at each section of the duct is recommended. (See Illustration 8M) (See Photo 7)

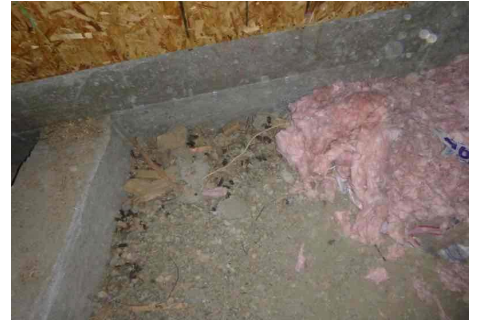
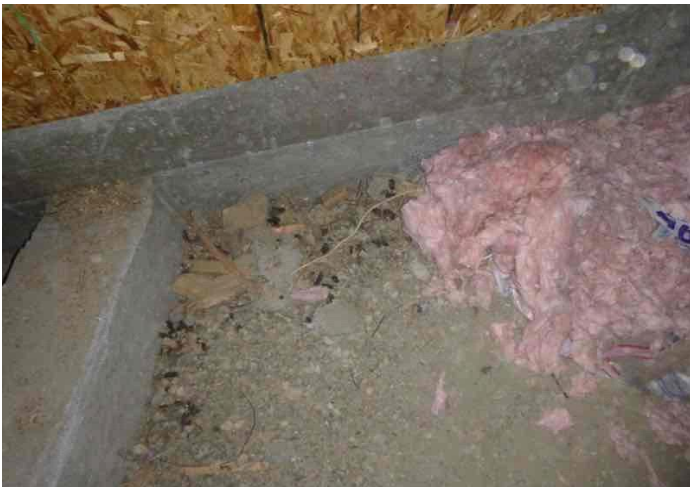
Photo 09

8. There is evidence of Vermin activity in the structure. It is likely that this infestation is also in inaccessible areas. The owner is advised to contact the appropriate trades for all remedial measures necessary. (See Photo 9)

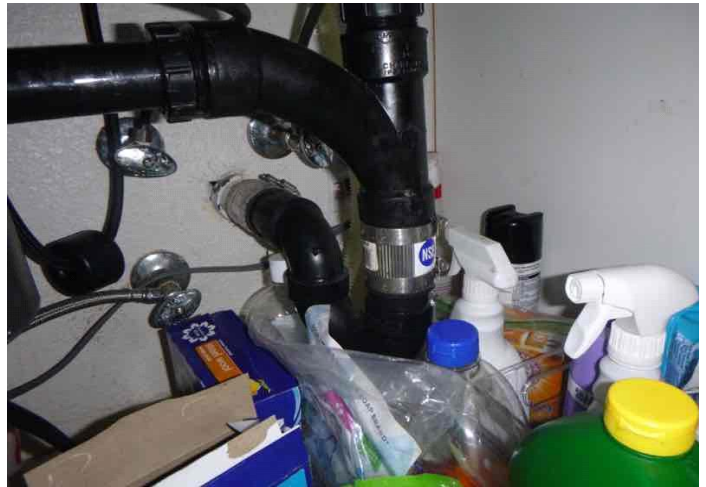
Photo 08

- 5. Improper materials and/or repairs were noted to the plumbing at the kitchen. These repairs are not likely to last or be effective. The non-conforming material and/or repairs should be corrected. (See Photo 8)
