Home Inspection Report

640 Dickinson Court, Discovery Bay

Tomas Carmona
September 20, 2023

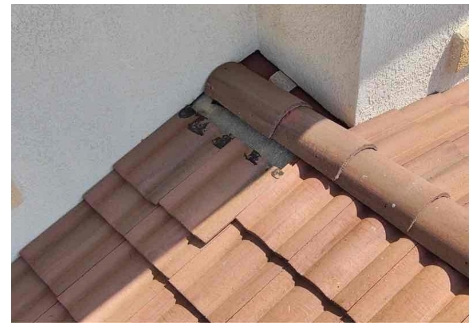
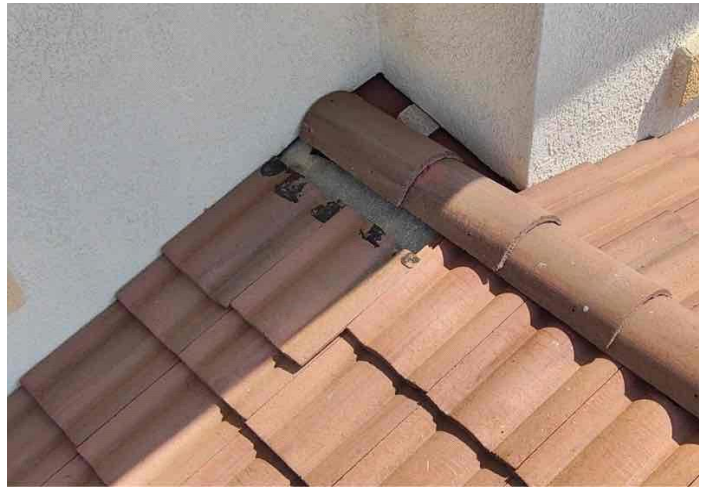
Photo 14

1. There are individual loose, cracked, and chipped tiles along the ridge and/or in the field. The number of affected tiles is small and no exposure of the underlayment membrane was evident. Further evaluation by a licensed roofer is recommended. (See Photo 14) (See Photo 15)

- ! 1. There are individual loose, cracked, and chipped tiles along the ridge and/or in the field. The number of affected tiles is small and no exposure of the underlayment membrane was evident. Further evaluation by a licensed roofer is recommended. (See Photo 14) (See Photo 15)
- ! 2. Leaks were noted in the downspouts and/or gutters at the left side and various areas. During wet weather conditions these areas are more obvious and during dry weather conditions they are noted from the stains at the areas where the leaks have occurred. We recommend all leaks be repaired. (See Illustration 2D) (See Photo 1)
- 3. Debris was noted on the roof covering. We recommend removing all debris to avoid creating water traps and to assist in the shedding of water from the roof.

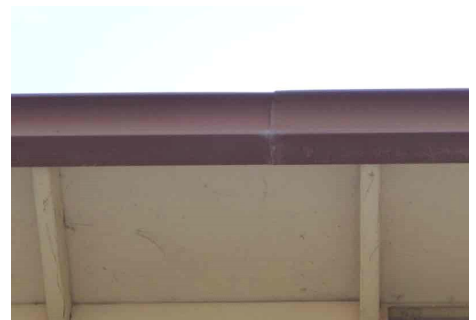
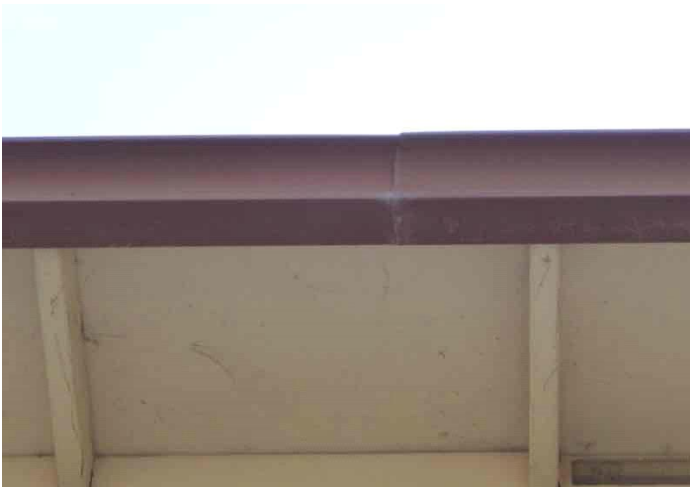
Photo 01

2. Leaks were noted in the downspouts and/or gutters at the left side and various areas. During wet weather conditions these areas are more obvious and during dry weather conditions they are noted from the stains at the areas where the leaks have occurred. We recommend all leaks be repaired. (See Illustration 2D) (See Photo 1)

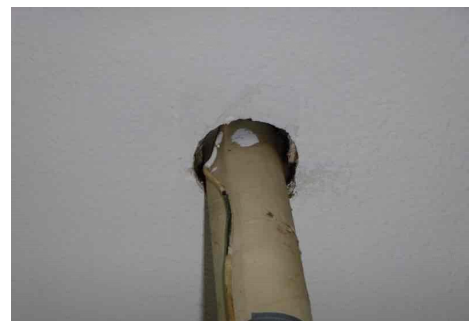
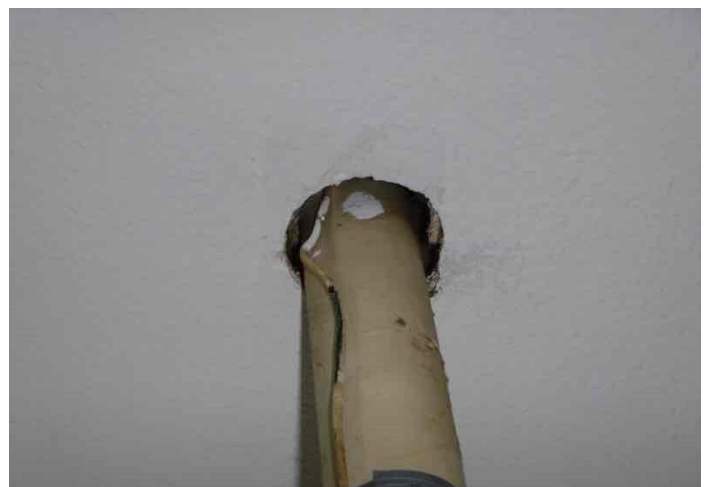
Photo 06

3. Damaged, open or missing wall and/or ceiling finishes of attached garages should be repaired and sealed where they abut the interior of a house. This reduces the potential of toxic automobile gases entering the house and serves as a fire break. Current standards require all walls/ceilings common to the finished living spaces be covered with 5/8" fire resistant sheetrock double taped at all seams. (See Illustration 3A) (See Photo 6)

- ! 1. Damaged, open or missing wall and/or ceiling finishes of attached garages should be repaired and sealed where they abut the interior of a house. This reduces the potential of toxic automobile gases entering the house and serves as a fire break. Current standards require all walls/ceilings common to the finished living spaces be covered with 5/8" fire resistant sheetrock double taped at all seams. (See Illustration 3A) (See Photo 6)

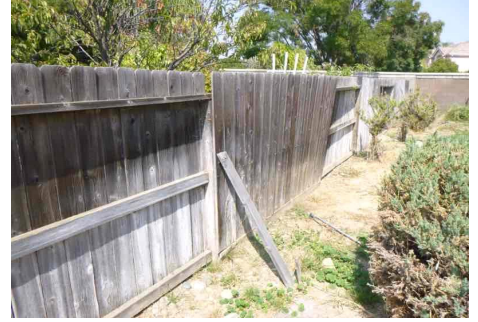
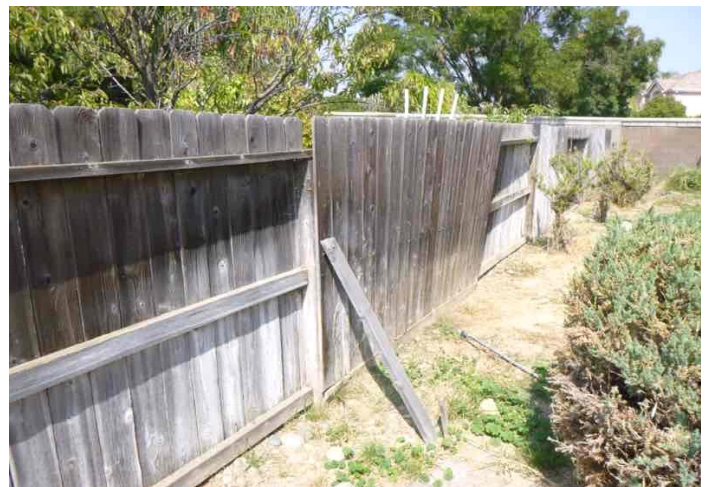
Photo 04

4. The wood fencing at the left side of the property is in need of repairs. (See Photo 4)

- ! 2. The wood fencing at the left side of the property is in need of repairs. (See Photo 4)
- ! 3. Water damage was observed to the roof eaves/sheathing at the front. We recommend the services of a licensed general contractor and/or structural pest control company. (See Photo 2)

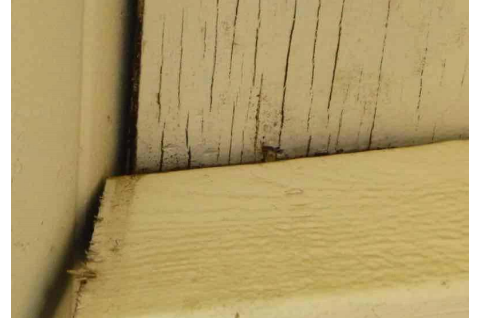
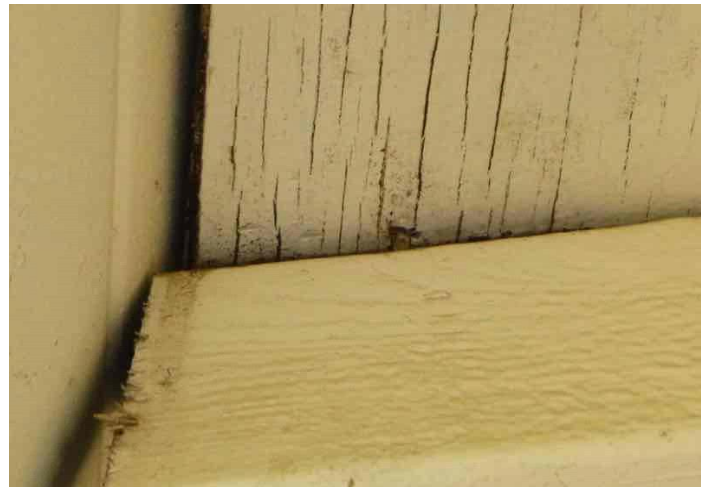
Photo 02

5. Water damage was observed to the roof eaves/sheathing at the front. We recommend the services of a licensed general contractor and/or structural pest control company. (See Photo 2)

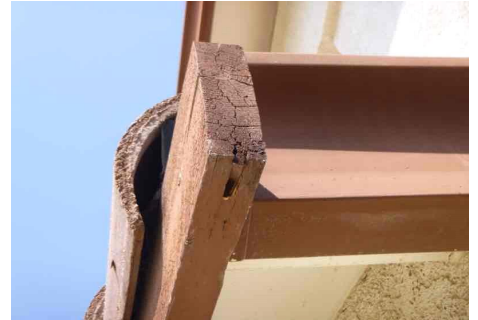
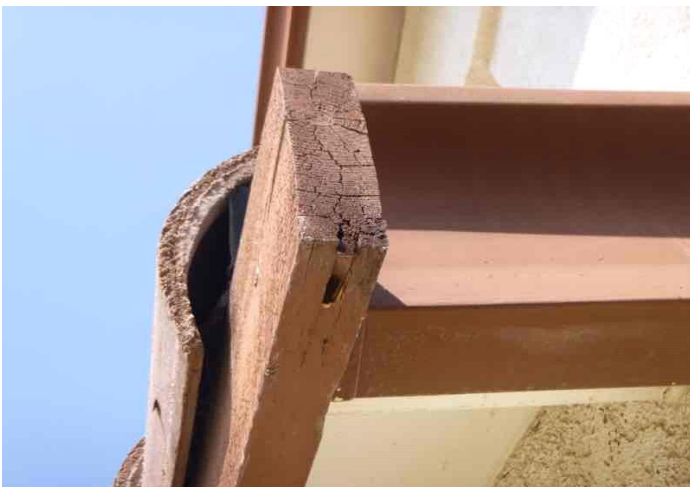
Photo 03

6. Water damage was observed to the rafters at the front. We recommend the services of a licensed general contractor and/or structural pest control company. (See Photo 3)

- ! 4. Water damage was observed to the rafters at the front. We recommend the services of a licensed general contractor and/or structural pest control company. (See Photo 3)

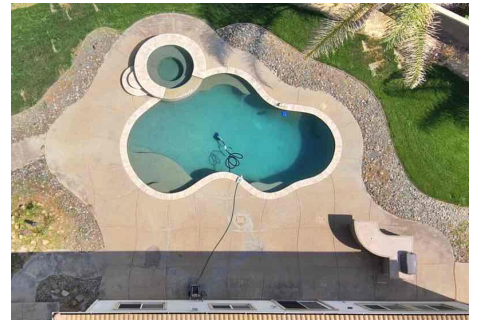
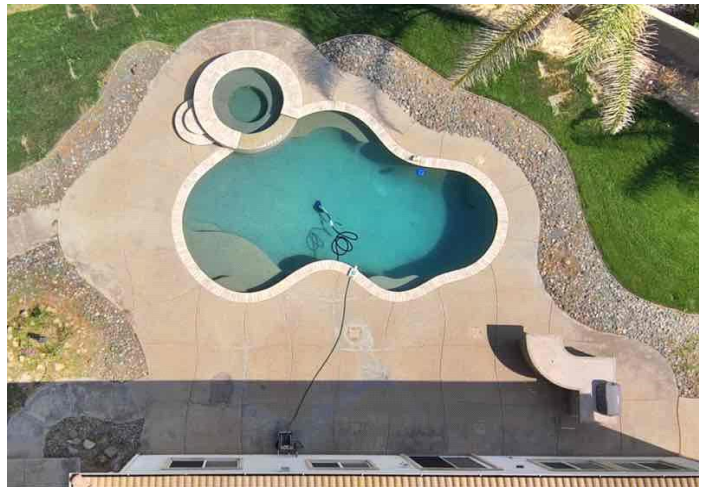
Photo 16

7. The pool and spa were not inspected; however, less than two drowning prevention safety features were noted. State law requires that during the course of our inspection we observe at least two of seven drowning prevention safety features outlined in the Health and Safety Code.

- (8) EXCEPTION: Hot tubs or spas with locking safety covers that comply with the American Society for Testing and Materials (ASTM F1346).
- The owner is advised to contact the appropriate trades to rectify this condition. (See Photo 16)

- ! 8. The pool and spa were not inspected; however, less than two drowning prevention safety features were noted. State law requires that during the course of our inspection we observe at least two of seven drowning prevention safety features outlined in the Health and Safety Code.

The owner is advised to contact the appropriate trades to rectify this condition. (See Photo 16)

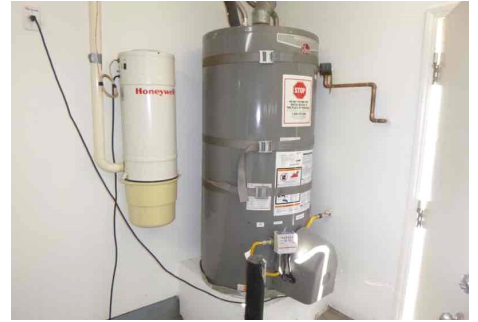
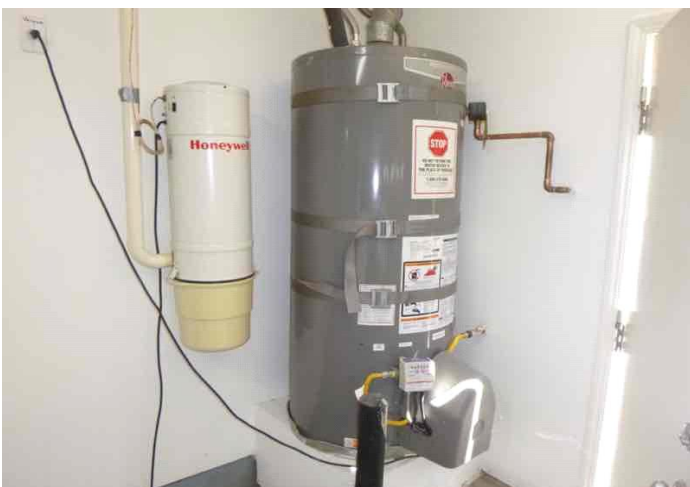
Photo 05

8. The water heater tank has been strapped in an improper manner and/or with improper material. We recommend the restraint be improved as per state codes. Specifically California state code is as follows.

- ! 1. The water heater tank has been strapped in an improper manner and/or with improper material. We recommend the restraint be improved as per state codes. Specifically California state code is as follows.

3. Straps may consist of either metal bands/tape at least 24 gauge or half-inch diameter metal conduit.
 4. Straps must wrap around the body of the water heater and any gaps between the wall and tank should be blocked to prevent movement.

5. Straps should be secured to adjacent wall or stud and from opposing directions
 6. Straps should be secured to the wall or studs using 1/4" diameter by 3" long lag bolts with washers. (See Illustration 8N) (See Photo 5)

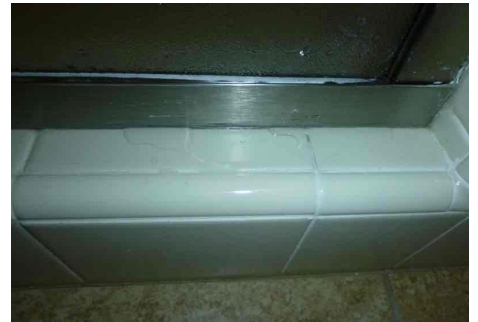
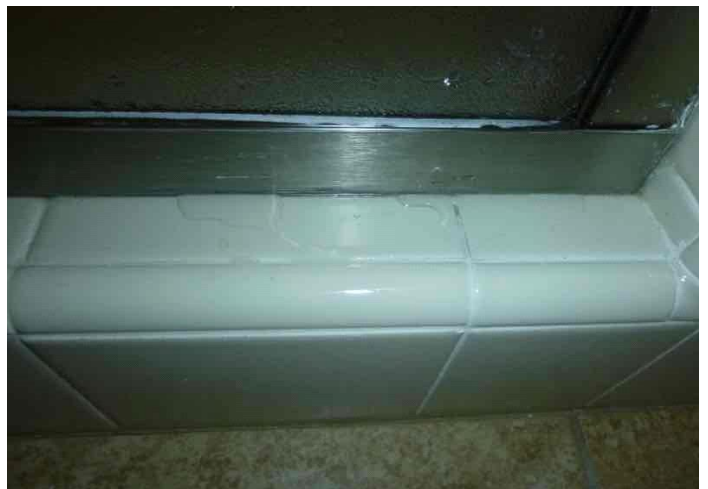
Photo 10

- ! 12. Cracked, deteriorated and/or missing shower enclosure caulk in the master bathroom should be replaced. Water leaking through non-sealed areas can cause damage. Damage caused by water seepage cannot be determined by this visual observation. (See Photo 10)

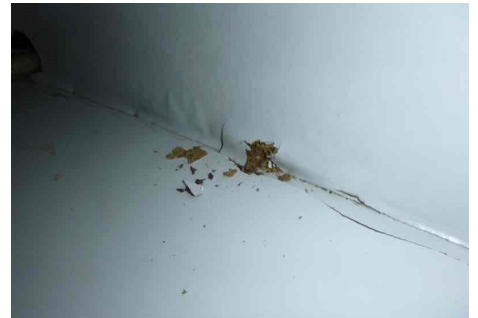
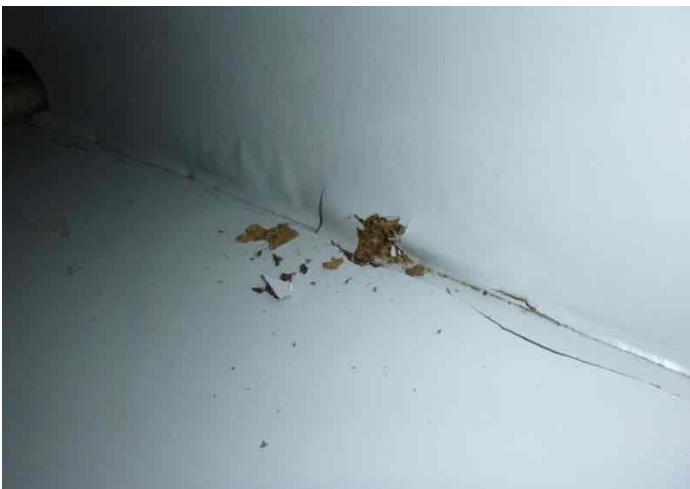
Photo 09

- ! 7. The base and/or side of the kitchen cabinet sink shelf is water damaged. We recommend the services of a licensed structural pest control operator for investigation of this condition. (See Photo 9)
8. The kitchen countertop or backsplash tile surface is cracked and/or chipped. This is a cosmetic consideration and repairs are optional.
9. Cracked, deteriorated and/or missing caulk at the kitchen sink, countertop, and backsplash should be replaced. A flexible caulking material is recommended rather than rigid cementitious grout.
10. The surface light under the microwave is inoperative. We recommend that the bulb be replaced and the operation verified.
11. The rack in the dishwasher is rusted. We recommend it be replaced.

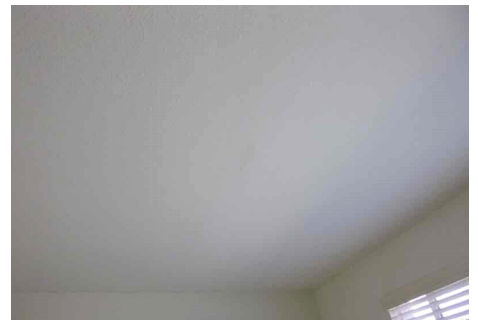
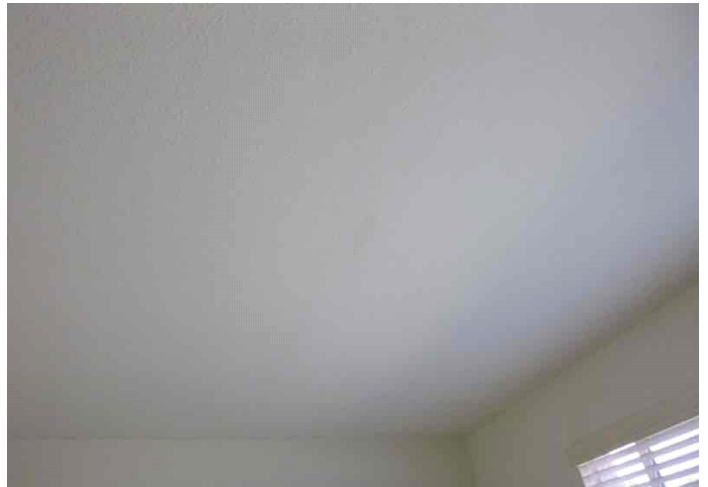
Photo 08

9. Cracked, deteriorated and/or missing shower enclosure caulk in the master bathroom should be replaced. Water leaking through non-sealed areas can cause damage. Damage caused by water seepage cannot be determined by this visual observation. (See Photo 10)
10. The base and/or side of the kitchen cabinet sink shelf is water damaged. We recommend the services of a licensed structural pest control operator for investigation of this condition. (See Photo 9)
11. The ceiling at the dining room shows evidence of stains. It is recommended that the source of these stains be identified and corrected and the surface be refinished. (See Photo 8)

- ! 1. The ceiling at the dining room shows evidence of stains. It is recommended that the source of these stains be identified and corrected and the surface be refinished. (See Photo 8)

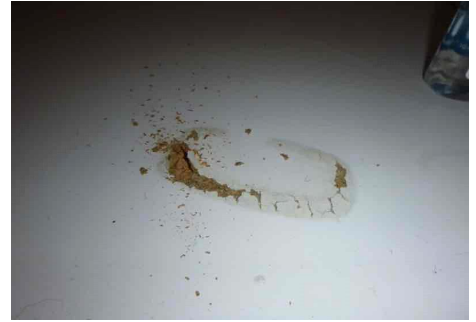
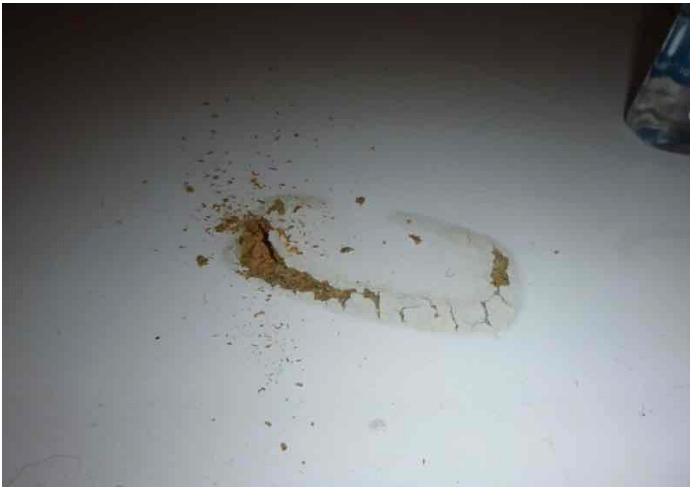
Photo 07

12. The base and/or side of the downstairs hall bathroom cabinet sink shelf is delaminated/deteriorated. We recommend the advice and services of a licensed pest control operator for investigation and possible repair of this condition. (See Photo 7)

- ! 13. The base and/or side of the downstairs hall bathroom cabinet sink shelf is delaminated/deteriorated. We recommend the advice and services of a licensed pest control operator for investigation and possible repair of this condition. (See Photo 7)

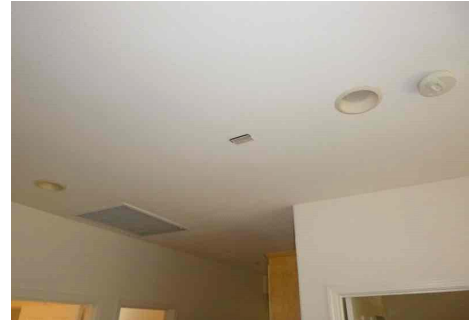
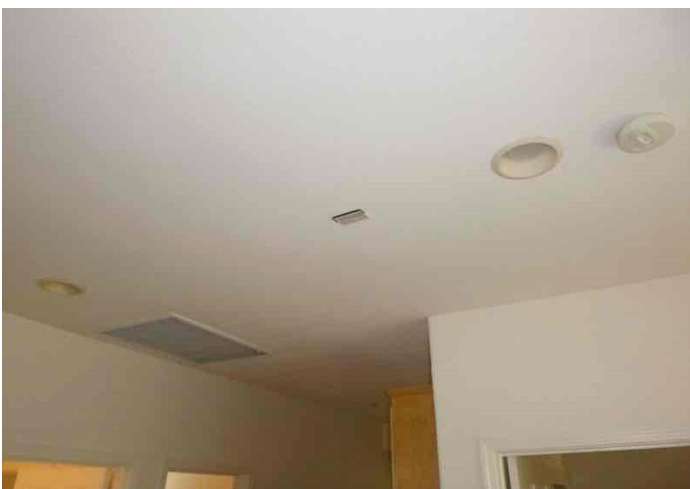
Photo 11

13. California law requires that all homes have a State Fire Marshall approved Carbon Monoxide Detector be installed outside of the sleeping areas in the hallway and on each level of the home including basements. At the time of this inspection the Carbon Monoxide Detectors could not be located. We recommend consulting with the owner to see if the Carbon Monoxide Detectors exist and if not they should be installed in all required locations. (See Photo 11)

- ! 2. California law requires that all homes have a State Fire Marshall approved Carbon Monoxide Detector be installed outside of the sleeping areas in the hallway and on each level of the home including basements. At the time of this inspection the Carbon Monoxide Detectors could not be located. We recommend consulting with the owner to see if the Carbon Monoxide Detectors exist and if not they should be installed in all required locations. (See Photo 11)

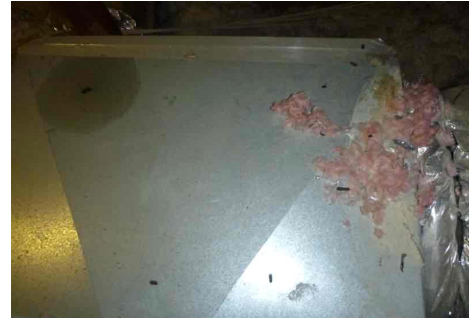
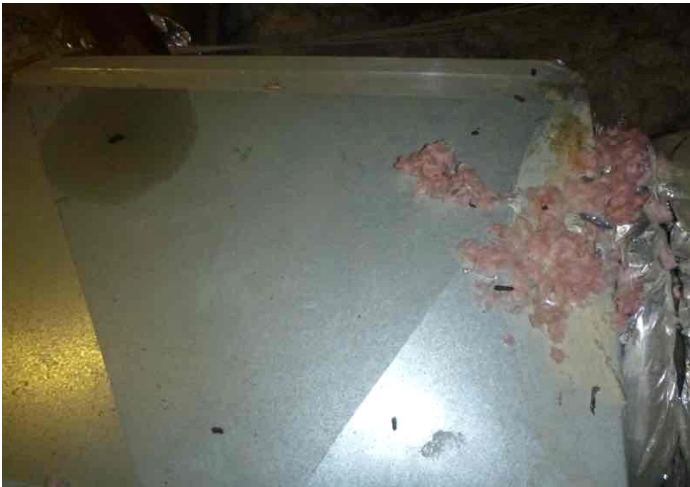
Photo 13

14. Evidence of vermin activity was observed within the attic. It is likely this evidence will extend into inaccessible areas. The owner is advised to contact the appropriate trade for further evaluation and remedial measures if necessary. (See Photo 13)

- ! 3. Evidence of vermin activity was observed within the attic. It is likely this evidence will extend into inaccessible areas. The owner is advised to contact the appropriate trade for further evaluation and remedial measures if necessary. (See Photo 13)

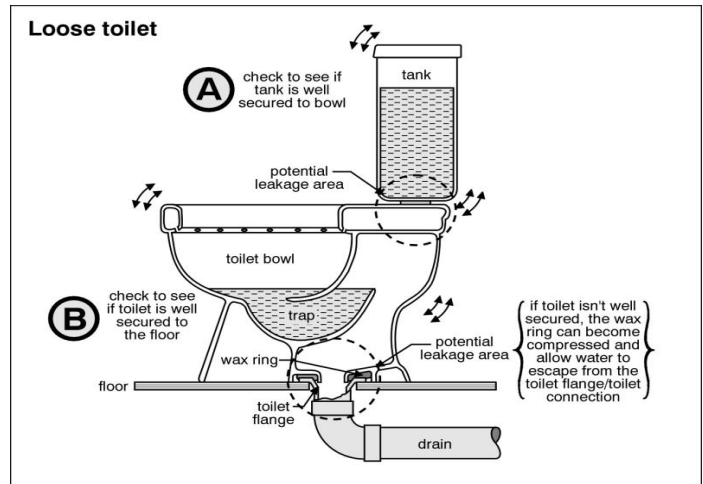
Illustration 8J

4. There is a gap between the tub spout and wall at the downstairs hall bathroom which should be sealed to prevent moisture intrusion.
5. The toilet at the downstairs hall bathroom is loose and should be properly re-secured, tightened and caulked. (See Illustration 8J)
