WOOD DESTROYING PESTS AND ORGANISM INSPECTION REPORT

Building No. 468	Street Rodriguez Avenue	City Martinez	ZIP 94553	Date of Inspection 5/27/2022	Number of Pages Page 1 of 8
<div style="display: flex; align-items: center;"> <div> 58 Wright Brothers Avenue Livermore, CA 94551 (855) 331-1900 • Fax (925) 294-1818 </div> </div>					
Registration #: PR1452		HomeGuard #: 594625		Escrow #:	
Ordered By: Sylvia Sotomayor eXp Realty 2603 Camino Ramon San Ramon, CA 94583		Property Owner/Party in Interest: Sean Chambers 468 Rodriguez Avenue Martinez, CA 94553		Report Sent to:	
COMPLETE REPORT <input checked="" type="checkbox"/> LIMITED REPORT <input type="checkbox"/> SUPPLEMENTAL REPORT <input type="checkbox"/> REINSPECTION REPORT <input type="checkbox"/>					
General Description: This is a two story single family dwelling with stucco exterior.				Inspection Tag Posted: Garage	
				Other Tags Posted: None noted	
An inspection has been made of the structure(s) shown on the diagram in accordance with the Structural Pest Control Act. Detached porches, detached steps, detached decks and any other structures not on the diagram were not inspected.

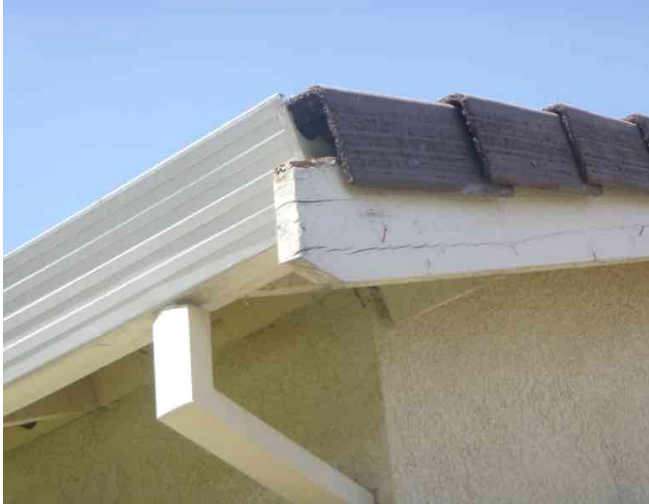
Photo 01

1A. FINDING: The barge rafter(s) as indicated on the diagram are damaged by fungus. The contributing moisture source appears to be exposure to the weather. (See Photo 1)

RECOMMENDATION: Remove and replace a section of the damaged barge rafter(s) to correct this condition. This bid includes repair of the roof covering if disturbed by our repairs. If existing gutters need to be removed to perform the repairs then our bid also includes reinstallation of original gutters. If it becomes necessary or desirable to install new gutters this will be done only if authorized and at an additional cost. The guarantees on the roof covering are limited to the areas where the work was performed.

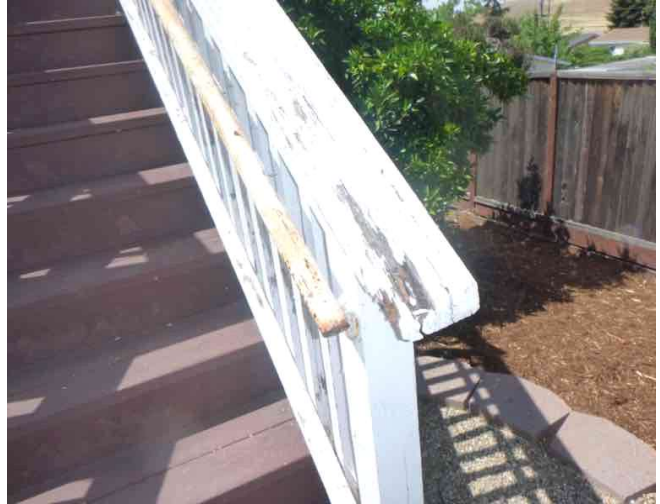
Photo 02

1B. FINDING: The handrail has been damaged by fungus at the rear deck. The contributing moisture source appears to be exposure to the weather. (See Photo 2)

1C. FINDING: The handrail has been damaged by fungus at the left side deck. The contributing moisture source appears to be exposure to the weather. (See Photo 2) (See Photo 3)

RECOMMENDATION: Remove and replace all the damaged wood members. If any damage is found to extend into any enclosed areas a supplemental report and bid will be issued.

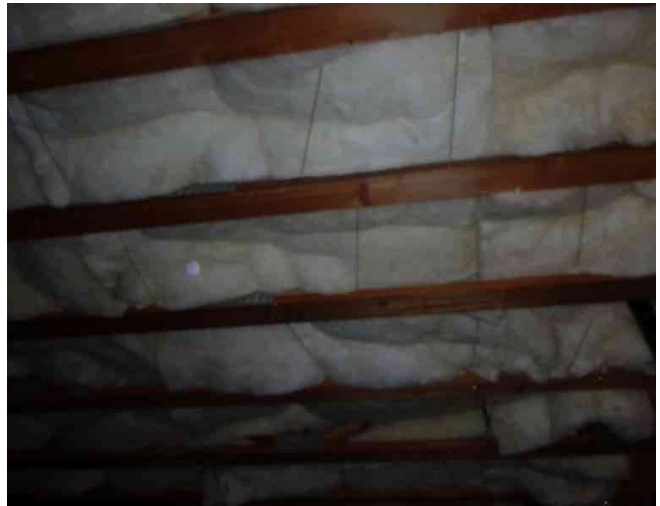
Photo 04

- 3A.** FINDING: The subfloor was insulated; however, no outward infections or infestations were noted at this time. Further inspection is recommended. (See Photo 4)

RECOMMENDATION: Remove the insulation from the perimeter of the structure and at all water pipe
Estimated Cost penetrations. Inspect the exposed wood members, and issue a supplemental report listing all findings, recommendations, and bids. Reinstall the insulation where removed upon completion.

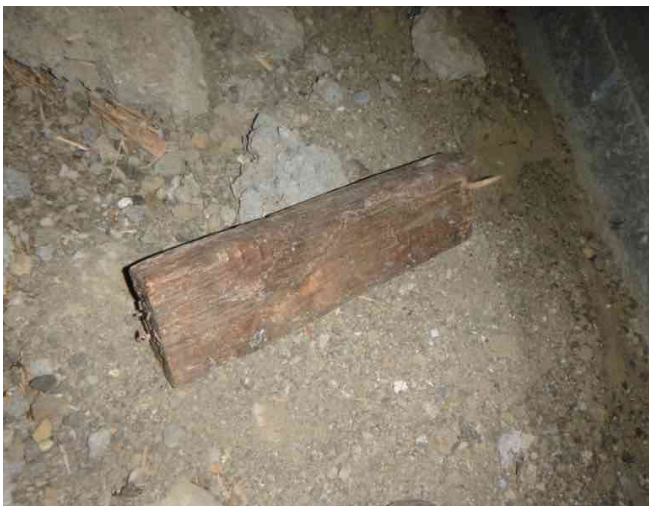
Photo 05

1D. FINDING: There is fungus infected cellulose debris and form boards in earth contact in the substructure area. (See Photo 7) (See Photo 5)

RECOMMENDATION: Remove the cellulose debris and form boards of a size that can be raked from the substructure area.

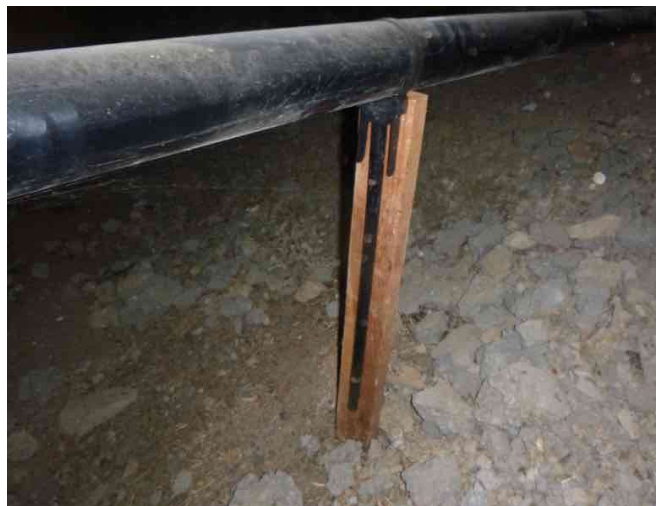
Photo 06

- 2C.** FINDING: There is earth contact in the substructure area at the wood blocking under the plumbing pipes. (See Photo 6)

RECOMMENDATION: Remove the wood blocking and strap the pipes in place with plumbers tape.
Estimated Cost

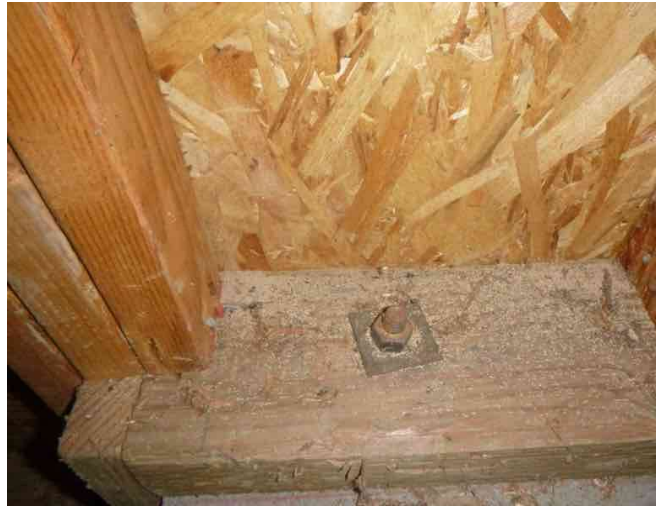
Photo 08

- 1E.** FINDING: Infestation by drywood termites was noted at the subarea cripple wall framing.
(See Photo 8) (See Photo 9)

- 1F.** FINDING: Drywood termite pellets were evident as noted in the above recommendation. (See Photo 8) (See Photo 9)

RECOMMENDATION: Drill and treat the infested areas with the registered termiticide Termidor
Estimated Cost HE(Fipronil:5-amino-1-(2,6-dichloro-4-(trifluoromethyl) phenyl)-4-((1,R,S)-trifluoromethyl)sulfinyl)-1-H-pyrazole-3-carbonitrile in a liquid formulation. NOTE: As drywood termites are a non-earth dwelling species, guarantees are limited to treated wood members only. NOTE: In order to perform this treatment the property must be vacated during the treatment and three hours after the treatment is performed. If any concealed pipes, conduit or electrical wiring or other facilities are drilled into during the course of performing this item it will be the owners responsibility and cost to repair these items.

RECOMMENDATION: Remove and/or mask over all accessible termite pellets. It is possible for the
Estimated Cost drywood termite pellets to sift down or reappear in these areas where they have been masked over.
