WOOD DESTROYING PESTS AND ORGANISM INSPECTION REPORT

Building No. 640	Street Dickinson Court	City Discovery Bay	ZIP 94505	Date of Inspection 9/20/2023	Number of Pages Page 1 of 7
<div style="display: flex; align-items: center;"> <div> 58 Wright Brothers Avenue Livermore, CA 94551 (855) 331-1900 • Fax (925) 294-1818 </div> </div>					
Registration #: PR1452		HomeGuard #: 623155		Escrow #:	
Ordered By: Sylvia Sotomayor 640 Dickinson Court Discovery Bay, CA 94505		Property Owner/Party in Interest: Todd Carter McPherson Real Estate at Remax 313 Sycamore Valley Road West Danville, CA 94526		Report Sent to:	
COMPLETE REPORT <input checked="" type="checkbox"/> LIMITED REPORT <input type="checkbox"/> SUPPLEMENTAL REPORT <input type="checkbox"/> REINSPECTION REPORT <input type="checkbox"/>					
General Description: This is a two story single family dwelling with stucco exterior.				Inspection Tag Posted: Garage	
				Other Tags Posted: None noted	
An inspection has been made of the structure(s) shown on the diagram in accordance with the Structural Pest Control Act. Detached porches, detached steps, detached decks and any other structures not on the diagram were not inspected.

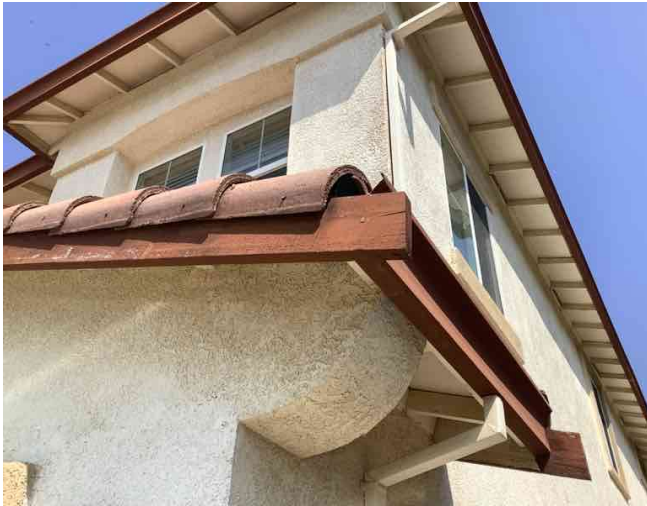
Photo 01

1A. FINDING: The barge rafter(s) as indicated on the diagram are damaged by fungus. The contributing moisture source appears to be exposure to the weather. [\(See Photo 1\)](#)

RECOMMENDATION: Remove and replace a section of the damaged barge rafter(s) to correct this [Estimated Cost](#) condition. This bid includes repair of the roof covering if disturbed by our repairs. If existing gutters need to be removed to perform the repairs then our bid also includes reinstallation of original gutters. If it becomes necessary or desirable to install new gutters this will be done only if authorized and at an additional cost. The guarantees on the roof covering are limited to the areas where the work was performed.

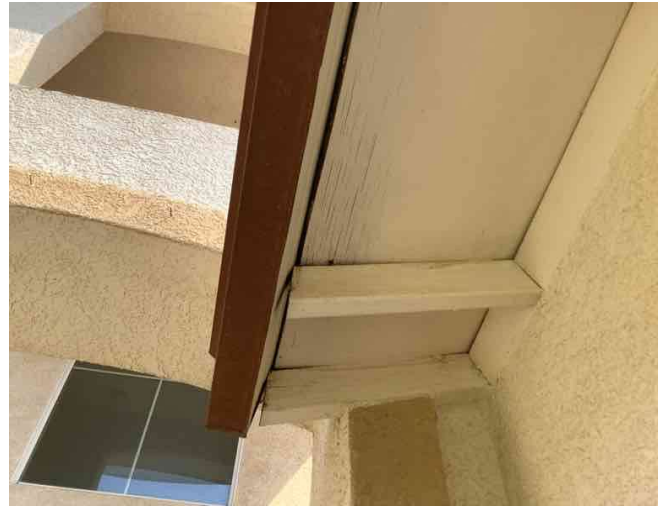
Photo 02

1B. FINDING: The roof sheathing has been damaged by fungus where indicated on the diagram. The contributing moisture source appears to have been caused by a failure of the roof covering. [\(See Photo 2\)](#)

RECOMMENDATION: Remove and replace the damaged sheathing to correct this condition. This bid [Estimated Cost](#) includes repair of the roof covering if disturbed by our repairs. If existing gutters need to be removed to perform the repairs then our bid also includes reinstallation of original gutters. If it becomes necessary or desirable to install new gutters this will be done only if authorized and at an additional expense. The guarantees on the roof covering are limited to the areas where the repairs were performed.

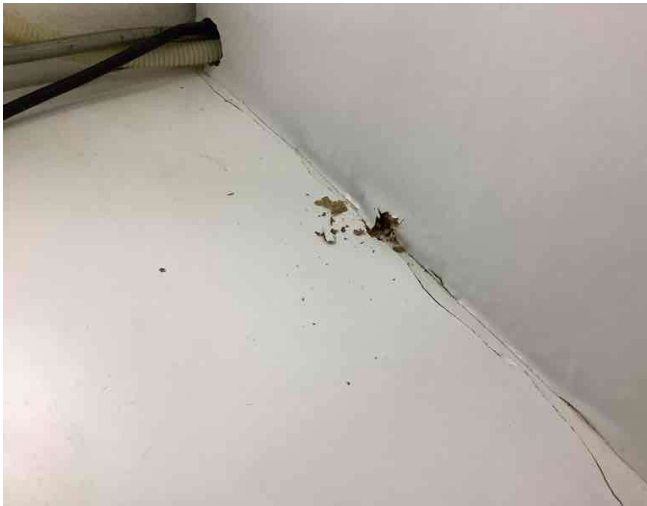
Photo 03

1C. FINDING: The shelf and sides under the sink in the kitchen have been damaged by fungus.
(See Photo 3)

RECOMMENDATION: Remove and replace the shelf and sides as necessary. Refer to item(s) 1D for
Estimated Cost recommendations to control contributing moisture conditions NOTE: If during the course of our repairs to the sink shelf it becomes necessary to modify/repair the adjacent plumbing facilities a supplemental report and bid will be issued.

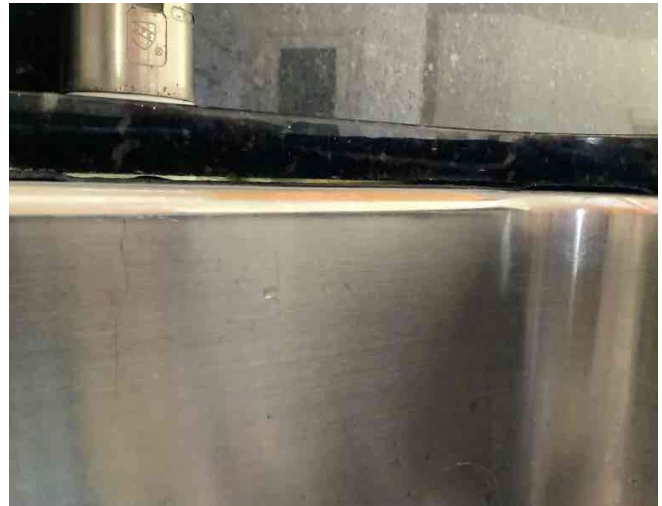
Photo 04

1D. FINDING: Water stains were noted beneath the kitchen sink. (See Photo 4)

NOTE: This condition has led to the damage as outlined in item 1C of this report.

RECOMMENDATION: Seal the area between the sink and counter top to prevent future moisture
Estimated Cost intrusion.

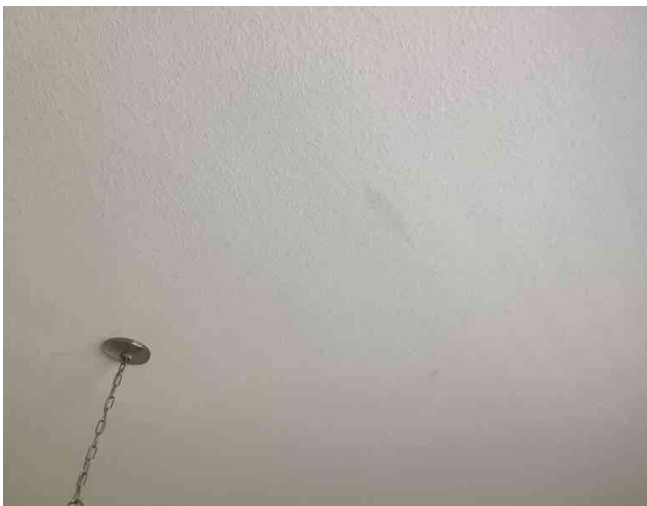
Photo 05

3A. FINDING: Water stains were noted on the ceiling in the dining room. The master bathroom mortar shower was noted to be directly above this area. (See Photo 5) (See Photo 6)

RECOMMENDATION: Open this area to determine the source of these stains and if any damage exists. All findings, recommendations, and bids will be issued in a supplemental report.

NOTE: The bid price for the previous item includes opening and closing this area only. It does not include any repairs or treatments that may be required. Once open we will perform a standard water test to the mortar shower.
